Fatality Assessment and Control Evaluation Program

FACE Report Number: 2005-10

Traffic Control Supervisor Dies When Struck By An Asphalt Dump Truck While Picking Up Cones on a Roadway Work Zone - Tennessee

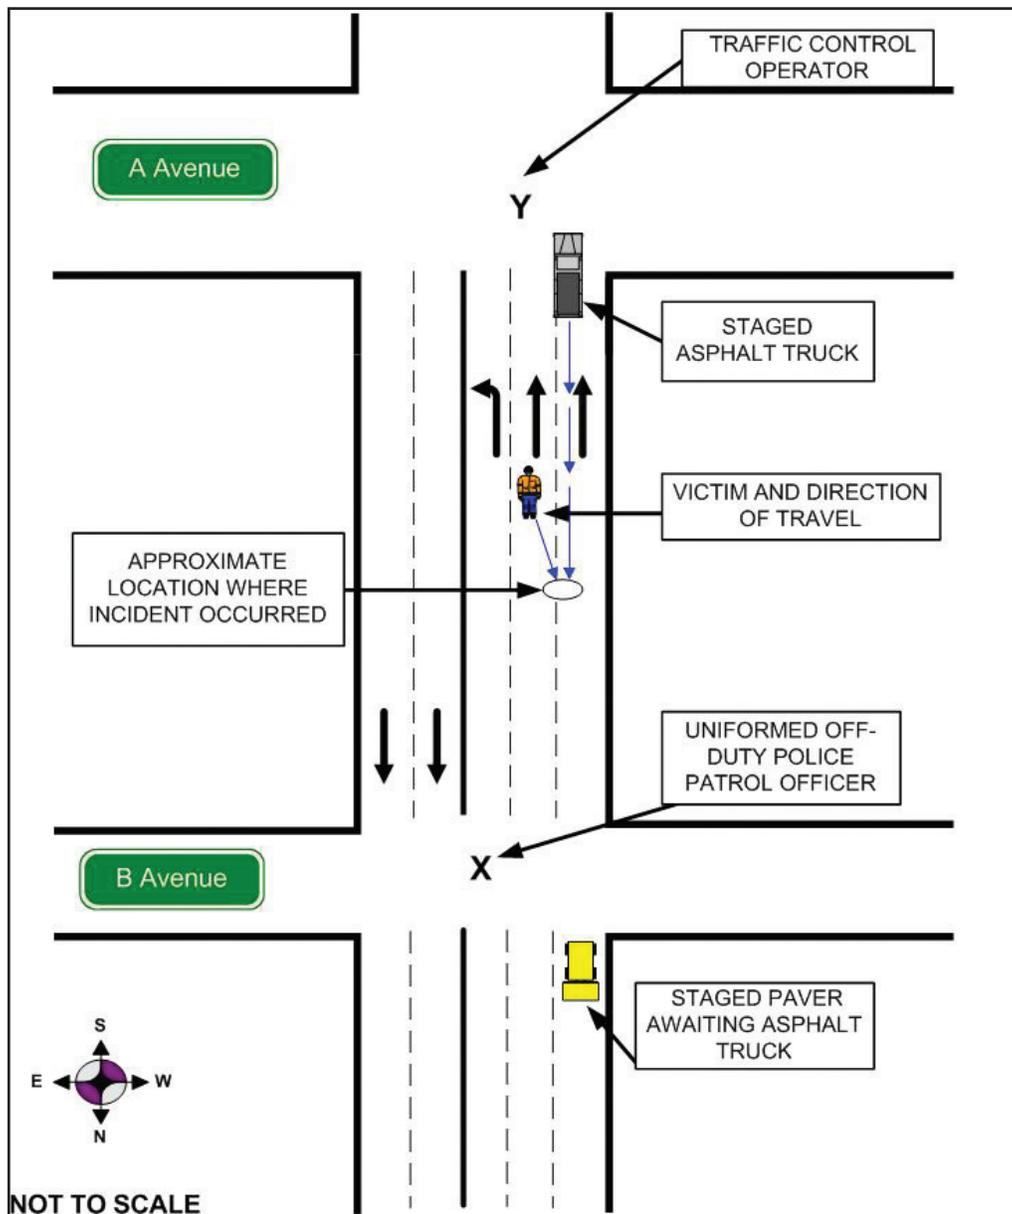
Diagram. Aerial view of incident scene

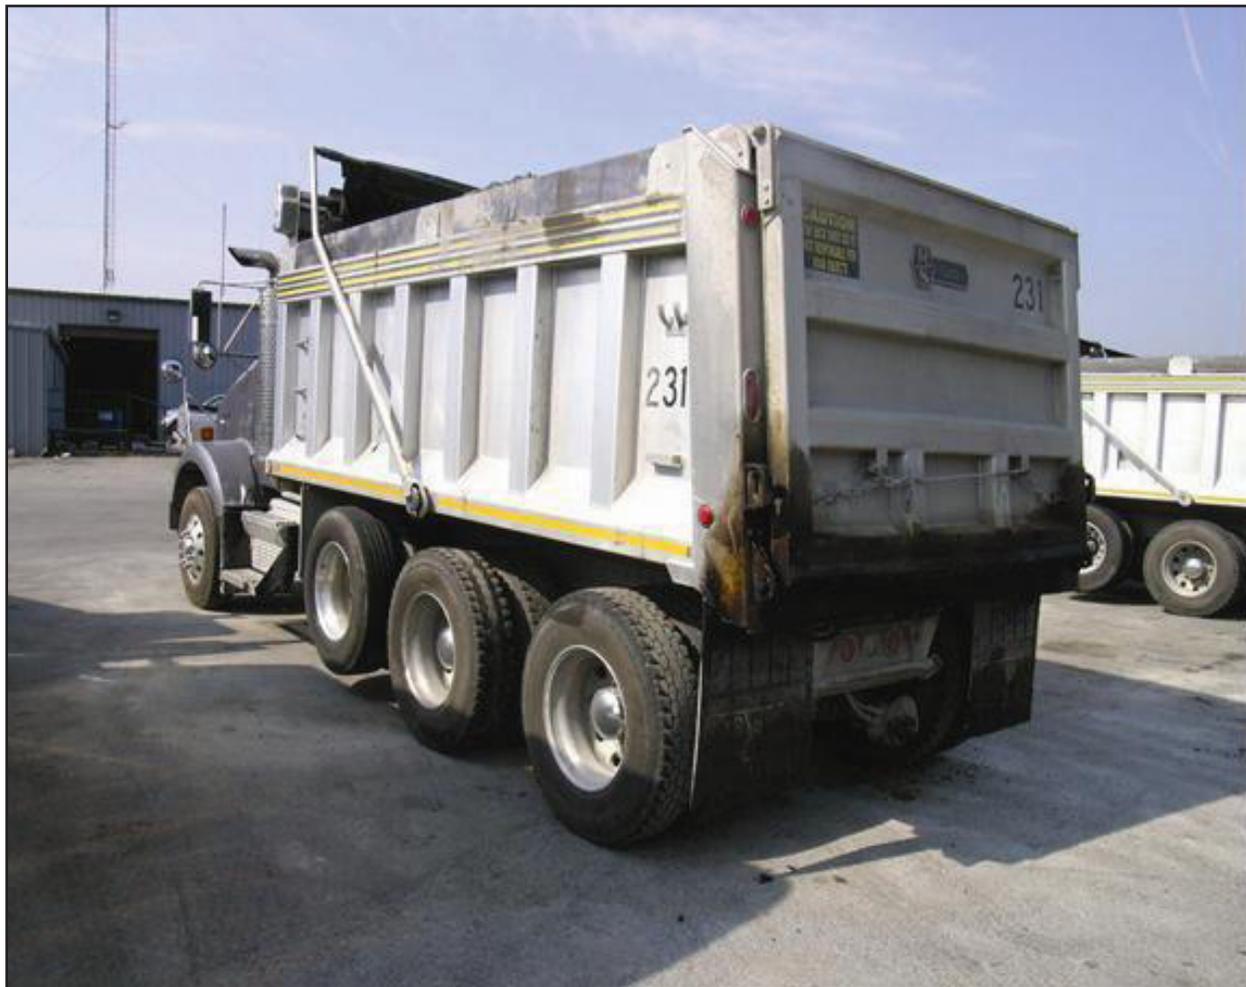
Equipment. The asphalt dump truck involved in this incident was owned and operated by the paving subcontractor. The diesel 5-ton tandem-axle truck was purchased new in 2004, and had a gross vehicle weight rating (GVWR) of 72,000 pounds (Photo 1).

Photo 1. Photo of the dump truck. [Photograph courtesy of the TOSHA].

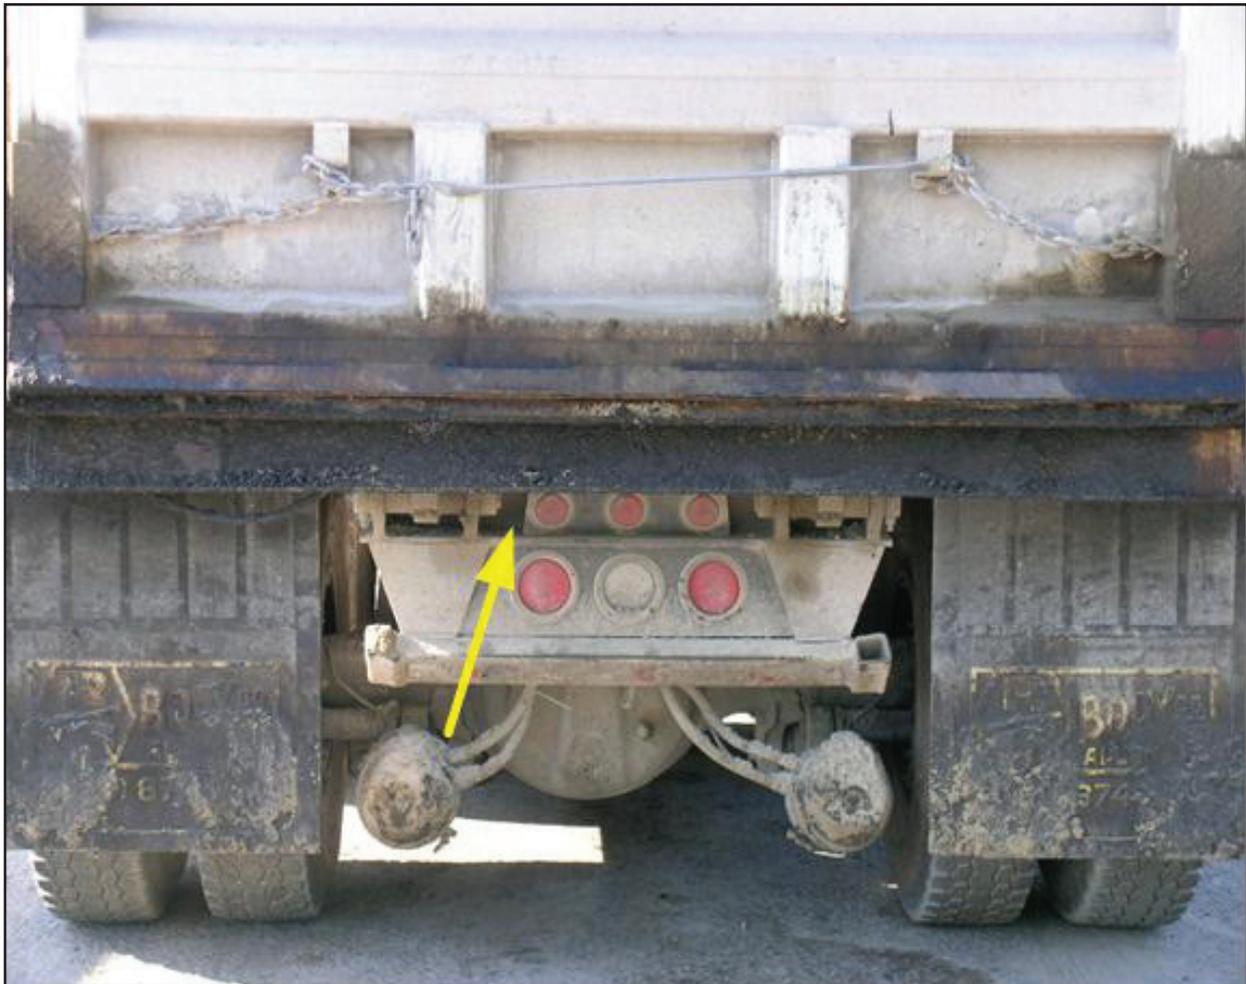
Following the purchase of the truck, a local vehicle dealer sent the chassis to an out-of-state company for the installation of the dump bed and to complete final assembly. Included in the installation and final assembly was the installment of an audible reverse alarm to the frame of the dump body (Photo 2 and Photo 3).

Photo 2. Photo shows a view of the rear of the truck. The reverse signal alarm is mounted behind the frame which is indicated by an arrow. [Photograph courtesy of the TOSHA].

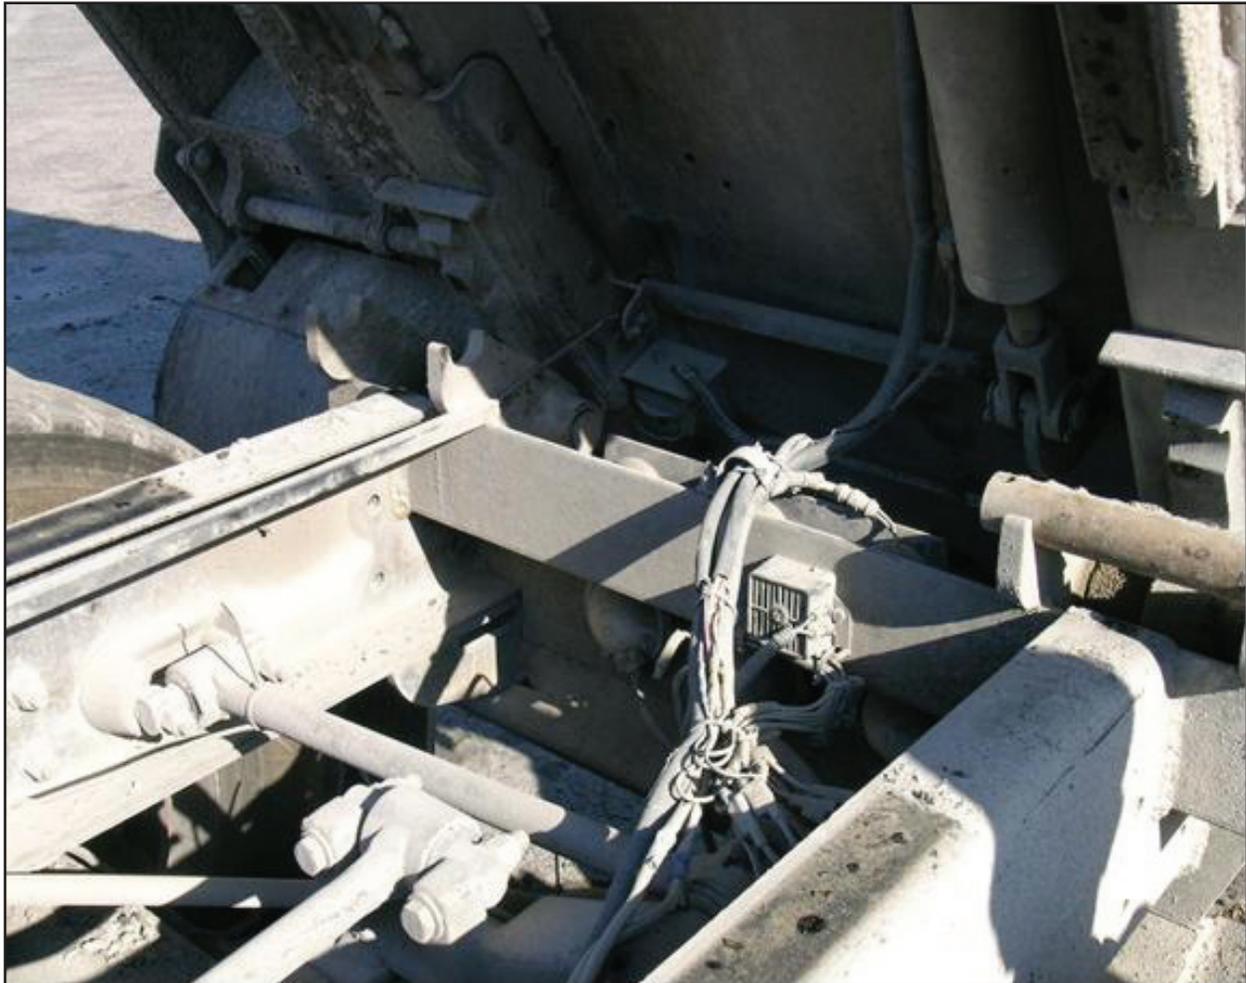
Photo 3. Photo shows the view under the raised dump bed. Note the grill of the reverse signal alarm which is facing towards the front of the truck. [Photograph courtesy of the TOSHA].

On May 17, 2005, at the paving contractor's office, TOSHA conducted an investigation of the truck and found that the reverse alarm was mounted on the frame panel with the sound grill opening facing the front of the truck (Photo 3). The reverse alarm manufacturer's installation instructions clearly stated that the sound opening grill should be mounted to face the target hazard area, which would be the rear of the truck. The TOSHA compliance officer conducted a sound level meter evaluation of the reverse alarm with the truck running. Sound pressure was measured at 82dB(a) at the rear of the truck, 74dB(a) approximately 10 feet from the rear of the truck, and 72 dB(a) 20 feet from the rear of the truck. TOSHA determined that the audible reverse alarm was functioning below the alarm manufacturer's rating level of 97 dB(a). It should be noted that TOSHA could not determine what the actual surrounding noise level was at the time of the incident.

Discussion: Following the employer's purchase of the new truck in this incident, the truck dealer sent it out of state for installation of the dump body and the audible reverse alarm. According to the manufacturer's installation instructions for the reverse alarm,¹⁰ for proper sound dispersion, the sound opening grill should be installed facing the targeted hazard area, which in this case would be the rear of the truck facing outward. According to the investigating TOSHA compliance officer, the alarm was functioning when it was tested after the incident; however, following further inspection, it was determined that the placement of the alarm did not follow the manufacturer's installation instructions. TOSHA determined that the reverse alarm was functioning below the alarm manufacturer's rating level of 97 dB(a).

Recommendation #5: Employers and companies performing any type of final assembly on construction vehicles should ensure that safety equipment is installed in accordance with the manufacturer's specifications and operates as intended.

When installing safety equipment on any construction vehicle or equipment, it is important to ensure that it is installed according to the manufacturer's installation specifications and is working to its optimal level as designed. It is imperative that an employer, prior to placing a new construction vehicle or equipment into service, completely inspect the vehicle to ensure that all safety features are installed correctly and are functioning at their optimal level. On this dump truck, the warning

alarm grill was visible when the dump bed was in the raised position. A visual inspection could identify an incorrect position installation. The reverse alarm sound level could also be checked by using a sound level meter, which would confirm the level at which the alarm is functioning.
