Nebraska FACE Investigation NE 2004-07

Engineering Technician Run Over and Killed by Backing Dump Truck

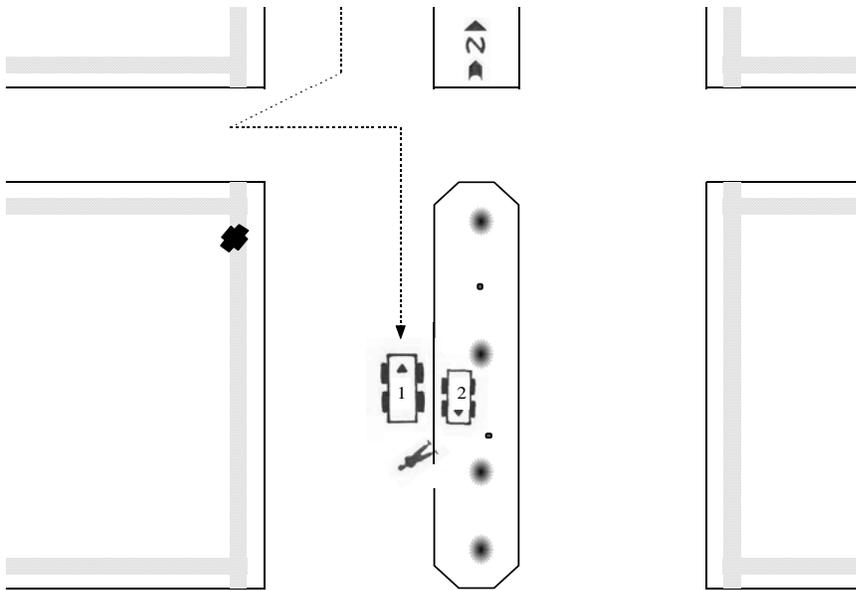
Attachment #1

Attachment 1. Site diagram (not to scale).

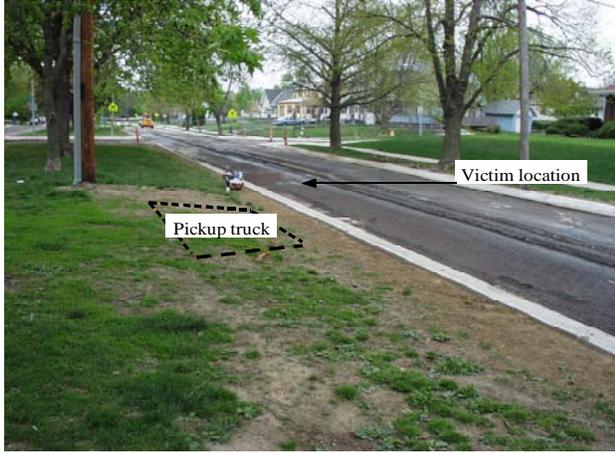
Attachment #2

Whenever practical, equipment, worker's private vehicles, materials, and debris should be stored in such a manner so it will not impede a vehicle operator's line-of-sight while operating construction equipment. The employee's personal vehicle that was parked in the median along the inner southbound curb may have hindered the dump truck operator from seeing the victim walking towards her in the median. She was only able to see behind her truck through the use of the door-mounted mirrors, as the dump box obscured her rear vision through the cab's rear glass.

Attachment 2. Top: Mishap site looking south. Note dotted line showing location of parked pickup truck and arrow indicating victim’s location when struck.
Bottom: Milling machine discharging asphalt residue into waiting dump truck.

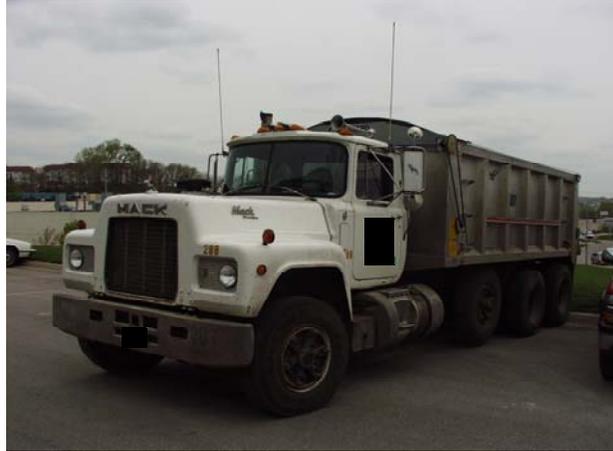
Attachment #3

The dump truck had passed the required annual DOT inspection conducted just prior to this incident. All safety related items were checked and were in working order. The operator conducted the pre-operational checklist prior to moving the truck from its parking location to the job site. Again, all lights and audible signals were working. Witnesses stated that they heard the back up alarms working on the dump truck just prior to the incident, and when Carrier Enforcement inspected it shortly after the incident, all were operating properly.

Attachment 3. Top: Side view of incident dump truck.
Bottom: Rear view of incident dump truck.
