## FACE INVESTIGATION #04WI019

### SUBJECT: Farmer Dies when Tractor rolls over on sloped Terrain

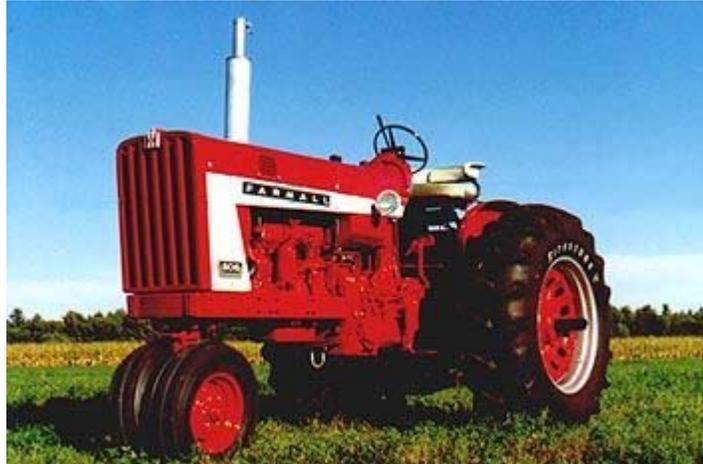
Figure 1. A Farmall 806 tricycle-front-end tractor like the one used in this incident.

Discussion: Tractor rollovers are the most common cause of fatal farm accidents. The Farmall model 806, like the tractor used in this incident has not been manufactured since 1967. It was not equipped with ROPS or seatbelts when it was manufactured. The Occupational Safety and Health Administration (OSHA) established the Rollover Protective Structure Standard to try to decrease the number of farm tractor overturn deaths in 1976. ROPS with a seatbelt have proven to decrease the risk of fatalities by offering a protective barrier to the victim in the case of an accidental rollover. ROPS are available for this model Farmall. It is important to use only the ROPS recommended by the manufacturer or tractor dealer. ROPS are engineered specifically for each tractor and must pass a series of dynamic and static tests. According to the National Farm Medicine Center in Marshfield, WI, "Due to dynamic forces which act upon a ROPS during a tractor rollover, it is imperative that a ROPS be properly designed, manufactured and installed. Proper materials and mounting hardware as well as engineering design are necessary to ensure safe performance. A ROPS is not something to be fabricated in the farm shop."
